**Flood Control Project Maintenance  
Levee Inspections**

**Maintenance Issue Types Only, Levee Inspection Report By Mile - Fall 2018**

**Reclamation District No. 2063 Crows Landing**

Waterway	Bank	Unit Miles	Inspection Start/End	Inspector
Unit No. 01 San Joaquin River	Right	10.44	10/31/2018 10/31/2018	Corey Fujitani

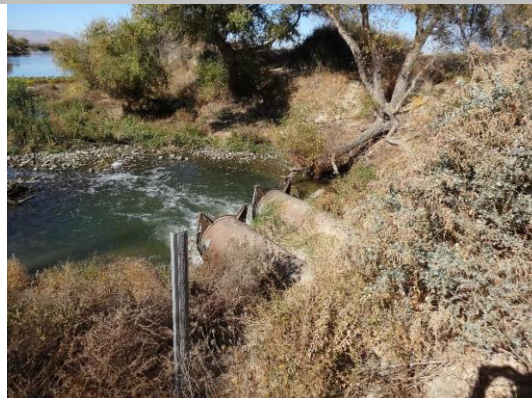
Photo 1 of 3 : UCIP\_FA\_2018\_50218\_43204.jpg

Comment Code						
Inspector Comment						
FS_ID:50218						
DS_ID:22076						
EP_NO: N/A						
Repair Type: No Action Needed						
Crossing Status: Found						
UCIP Comments: 08/23/2016: WS flapgates were held open by a piece of wood. Pipes may be used temporarily for irrigation. (K. Fazel - UCIP)11/05/2013: working during the inspection. (P. Amatya - DWR)						
FIELD_STRUCT_DESC: [Lateral Drain No. 5] 1 of 2: 48-inch corrugated metal gravity drainage pipe through the levee, 25.5 feet below the crown. Slide gate in a corrugated metal pipe (CMP) riser on the waterside (WS) slope. Flap gate on the WS end. 70-foot-long cobble spillway to river. Installed by USACE in 1961. [Additional Reference(s): DWR Levee Log, 1992. USACE San Joaquin O&M Manual 6, September 1961, (HLM 1.35)].						
FS Date: 11/5/2013

WS view: two outfall CMP pipes on levee slope.

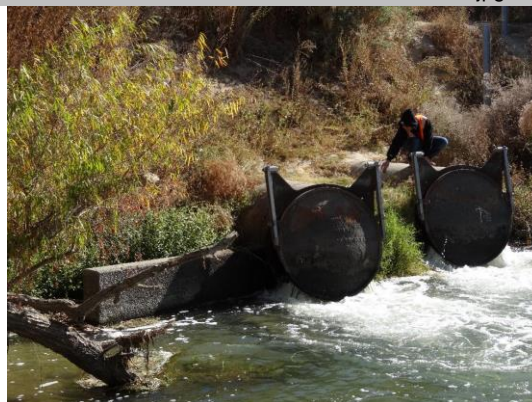
Photo 2 of 3 : UCIP\_FA\_2018\_50218\_43203.jpg

WS view: two outfall CMP pipes with flap gates on concrete headwall.

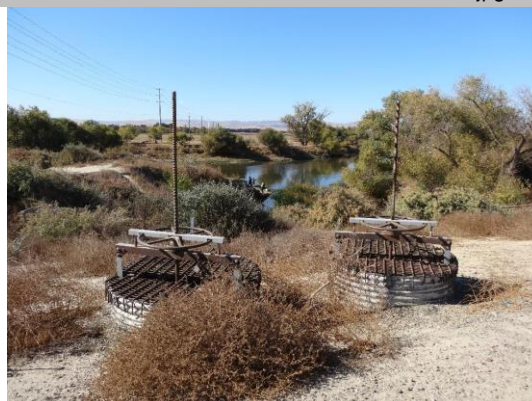
Photo 3 of 3 : UCIP\_FA\_2018\_50218\_43202.jpg

Comment Code						
Inspector Comment						
FS_ID:50218						
DS_ID:22076						
EP_NO: N/A						
Repair Type: No Action Needed						
Crossing Status: Found						
UCIP Comments: 08/23/2016: WS flapgates were held open by a piece of wood. Pipes may be used temporarily for irrigation. (K. Fazel - UCIP)11/05/2013: working during the inspection. (P. Amatya - DWR)						
FIELD_STRUCT_DESC: [Lateral Drain No. 5] 1 of 2: 48-inch corrugated metal gravity drainage pipe through the levee, 25.5 feet below the crown. Slide gate in a corrugated metal pipe (CMP) riser on the waterside (WS) slope. Flap gate on the WS end. 70-foot-long cobble spillway to river. Installed by USACE in 1961. [Additional Reference(s): DWR Levee Log, 1992. USACE San Joaquin O&M Manual 6, September 1961, (HLM 1.35)].						
FS Date: 11/5/2013

WS view: two slide gates in CMP risers on levee slope.

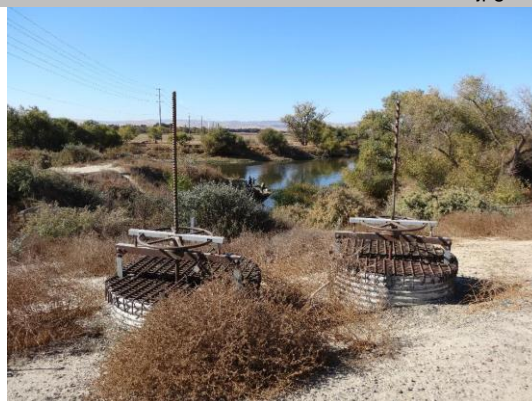
Photo 1 of 3 : UCIP\_FA\_2018\_50217\_43217.jpg

Comment Code						
Inspector Comment						
FS_ID:50217						
DS_ID:22119						
EP_NO: N/A						
Repair Type: No Action Needed						
Crossing Status: Found						
UCIP Comments: 08/23/2016: WS flapgates were held open by a piece of wood. Pipes may be used temporarily for irrigation. (K. Fazel - UCIP)11/05/2013: working during field inspection. (P. Amatya - DWR)						
FIELD_STRUCT_DESC: [Lateral Drain No. 5] 2 of 2: 48-inch corrugated metal gravity drainage pipe through the levee, 25.5 feet below the crown. Slide gate in a corrugated metal pipe (CMP) riser on the waterside (WS) slope. Flap gate on the WS end. 70-foot-long cobble spillway to river. Installed by USACE in 1961. [Additional Reference(s): DWR Levee Log, 1992. USACE San Joaquin O&M Manual 6, September 1961, (HLM 1.35)].						
FS Date: 11/5/2013

WS view: two CMP risers with slide gates on levee slope.

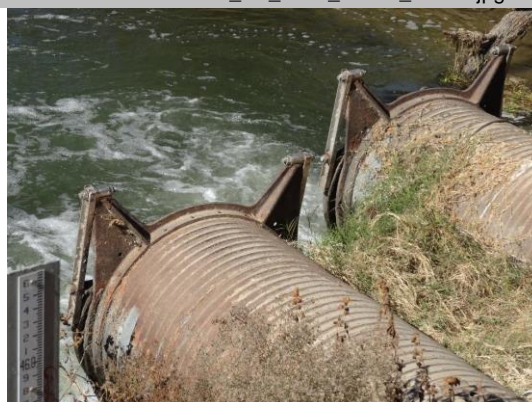
Photo 2 of 3 : UCIP\_FA\_2018\_50217\_43216.jpg

WS view: two CMP outfall pipes with flap gates on levee slope.

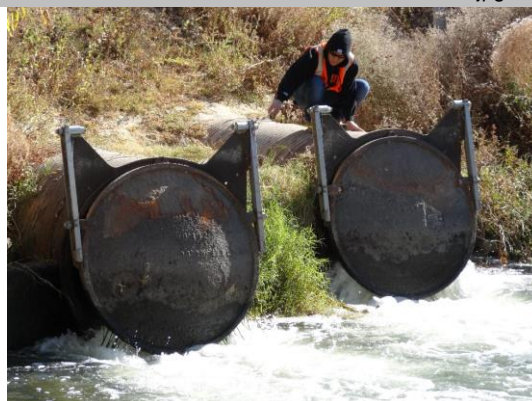
Photo 3 of 3 : UCIP\_FA\_2018\_50217\_43215.jpg

Comment Code						
Inspector Comment						
FS_ID:50217						
DS_ID:22119						
EP_NO: N/A						
Repair Type: No Action Needed						
Crossing Status: Found						
UCIP Comments: 08/23/2016: WS flapgates were held open by a piece of wood. Pipes may be used temporarily for irrigation. (K. Fazel - UCIP)11/05/2013: working during field inspection. (P. Amatya - DWR)						
FIELD_STRUCT_DESC: [Lateral Drain No. 5] 2 of 2: 48-inch corrugated metal gravity drainage pipe through the levee, 25.5 feet below the crown. Slide gate in a corrugated metal pipe (CMP) riser on the waterside (WS) slope. Flap gate on the WS end. 70-foot-long cobble spillway to river. Installed by USACE in 1961. [Additional Reference(s): DWR Levee Log, 1992. USACE San Joaquin O&M Manual 6, September 1961, (HLM 1.35)].						
FS Date: 11/5/2013

WS view: front view of two CMP outfall pipes with flap gates on levee slope.

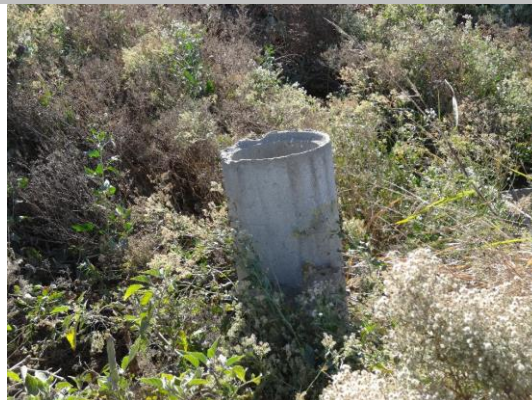
Photo 1 of 3 : UCIP\_FA\_2018\_51823\_43348.jpg

Comment Code					
Inspector Comment					
FS_ID:51823 DS_ID:22081 EP_NO: N/A Repair Type: No Action Needed Crossing Status: Found UCIP Comments: 11/05/2013 - concrete standpipe on waterside toe.- concrete distribution box on landside.- an alfalfa valve on waterside toe. (P. Amatya - DWR UCIP) FIELD_STRUCT_DESC: 30-inch corrugated metal gravity drainage pipe through the levee, 12 feet below the crown. Flap gate on the waterside (WS) end. Slide gate in a concrete distribution box on the landside (LS) end. Concrete U-shaped headwall on the WS end. [Additional Reference(s): DWR Levee Log, 1992. USACE San Joaquin O&M Manual 6, September 1961, (HLM 2.29)]. FS Date: 11/5/2013

WS view: concrete standpipe on levee toe.

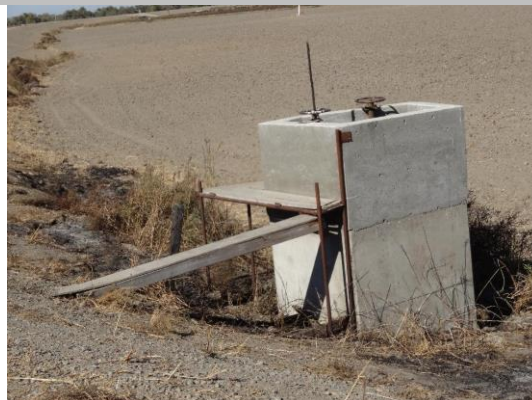
Photo 2 of 3 : UCIP\_FA\_2018\_51823\_43347.jpg

LS view: concrete distribution box and temporary walkway on levee toe.

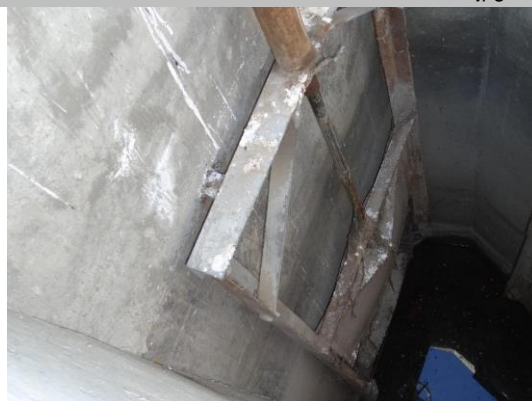
Photo 3 of 3 : UCIP\_FA\_2018\_51823\_43346.jpg

Comment Code						
Inspector Comment						
FS_ID:51823						
DS_ID:22081						
EP_NO: N/A						
Repair Type: No Action Needed						
Crossing Status: Found						
UCIP Comments: 11/05/2013 - concrete standpipe on waterside toe.- concrete distribution box on landside.- an alfalfa valve on waterside toe. (P. Amatya - DWR UCIP)						
FIELD_STRUCT_DESC: 30-inch corrugated metal gravity drainage pipe through the levee, 12 feet below the crown. Flap gate on the waterside (WS) end. Slide gate in a concrete distribution box on the landside (LS) end. Concrete U-shaped headwall on the WS end. [Additional Reference(s): DWR Levee Log, 1992. USACE San Joaquin O&M Manual 6, September 1961, (HLM 2.29)].						
FS Date: 11/5/2013

LS view: slide gate in concrete distribution box.

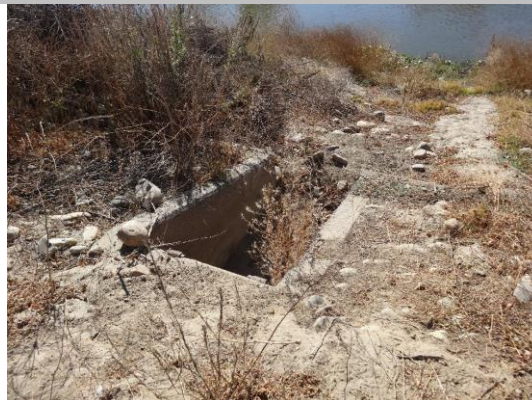
Photo 1 of 3 : UCIP\_FA\_2018\_24435\_43484.jpg

LM Start	2.62	Rating **	M	Issue No.	67	
LM End	2.62	Issue Type +	Ma	Location *		
Category	Supplemental			GPS Latitude/Longitude		
				Start	End	
Item	DWR UCIP LMA Responsibility			37.448233 °	37.448233 °	
				-121.026521 °	-121.026521 °	
DWR ID	22086					
Comment Code						
Inspector Comment						
FS_ID:24435 DS_ID:22086 EP_NO: N/A Repair Type: Non-Urgent Crossing Status: Found UCIP Comments: 11/05/2013 Both pipe ends 70 ft off the levee center.Clearing and cleaning of inlet/outlet pipe needed. (P. Amatya - DWR UCIP) FIELD_STRUCT_DESC: 24-inch corrugated metal gravity drainage pipe through the levee, 12 feet below the crown. Flap gate on the waterside (WS) end. Concrete headwall on each end. Installed by USACE in 1961. [Additional Reference(s): DWR Levee Log, 1992. USACE San Joaquin O&M Manual 6, September 1961, (HLM 2.65)]. FS Date: 11/5/2013

WS view: U shaped headwall outlet structure 70 ft off the levee center.

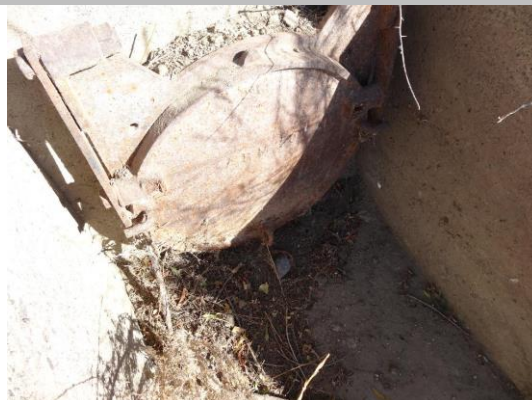
Photo 2 of 3 : UCIP\_FA\_2018\_24435\_43483.jpg

WS view: U shaped headwall outlet structure and pipe with flap gate.

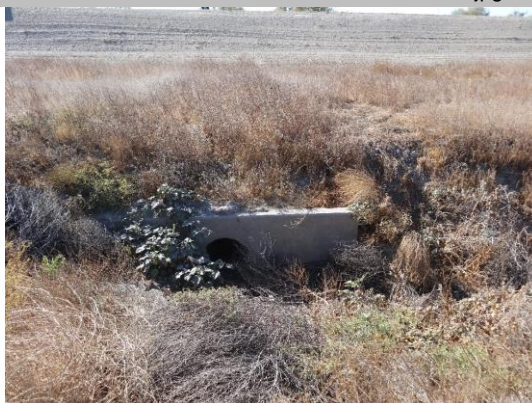
Photo 3 of 3 : UCIP\_FA\_2018\_24435\_43482.jpg

Comment Code						
Inspector Comment						
FS_ID:24435						
DS_ID:22086						
EP_NO: N/A						
Repair Type: Non-Urgent						
Crossing Status: Found						
UCIP Comments: 11/05/2013 Both pipe ends 70 ft off the levee center.Clearing and cleaning of inlet/outlet pipe needed. (P. Amatya - DWR UCIP)						
FIELD_STRUCT_DESC: 24-inch corrugated metal gravity drainage pipe through the levee, 12 feet below the crown. Flap gate on the waterside (WS) end. Concrete headwall on each end. Installed by USACE in 1961. [Additional Reference(s): DWR Levee Log, 1992. USACE San Joaquin O&M Manual 6, September 1961, (HLM 2.65)].						
FS Date: 11/5/2013

LS view: concrete headwall with CMP 70 ft off the levee center.

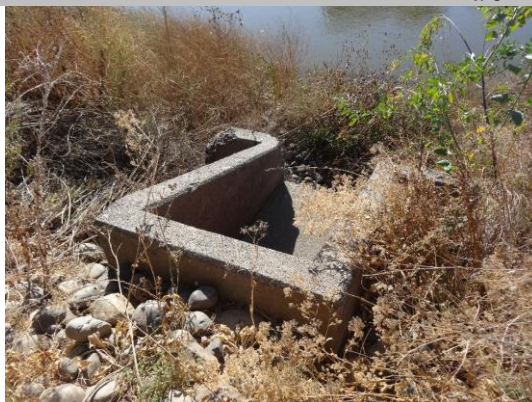
Photo 1 of 3 : UCIP\_FA\_2018\_25023\_45102.jpg

LM Start	2.68	Rating **	A/W	Issue No.	68
LM End	2.68	Issue Type +	Ma	Location *	
Category	Supplemental			GPS Latitude/Longitude	
				Start	End
Item	DWR UCIP LMA Responsibility			37.447475 °	37.447475 °
				-121.026017 °	-121.026017 °
DWR ID	22087				
Comment Code					
Inspector Comment					
FS_ID:25023					
DS_ID:22087					
EP_NO: N/A					
Repair Type: No Action Needed					
Crossing Status: Found					
UCIP Comments: 11/05/2013 Both pipe ends about 85 feet off the levee center. (P. Amatya - DWR UCIP)					
FIELD_STRUCT_DESC: 24-inch corrugated metal gravity drainage pipe through the levee, 20.3 feet below the crown. Flap gate on the waterside (WS) end. Concrete headwall on each end. Installed by USACE in 1961. [Additional Reference(s): DWR Levee Log, 1992. USACE San Joaquin O&M Manual 6, September 1961, (HLM 2.71)].					
FS Date: 11/5/2013

WS view: U typed concrete headwall on river bank.

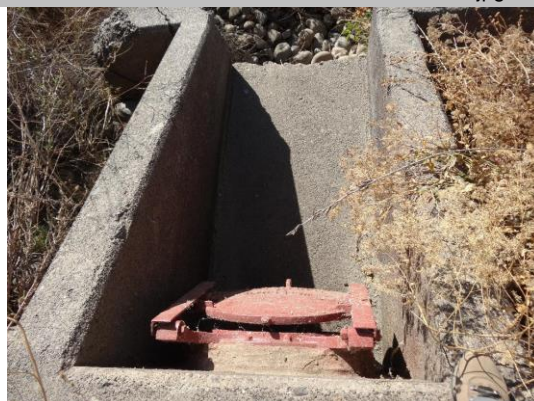
Photo 2 of 3 : UCIP\_FA\_2018\_25023\_45101.jpg

LM Start	2.68	Rating **	A/W	Issue No.	68 (cont)	
LM End	2.68	Issue Type +	Ma	Location *		
Category	Supplemental			GPS Latitude/Longitude		
				Start	End	
Item	DWR UCIP LMA Responsibility			37.447475 °	37.447475 °	
				-121.026017 °	-121.026017 °	
DWR ID	22087					
Comment Code						
Inspector Comment						
FS_ID:25023 DS_ID:22087 EP_NO: N/A Repair Type: No Action Needed Crossing Status: Found UCIP Comments: 11/05/2013 Both pipe ends about 85 feet off the levee center. (P. Amatya - DWR UCIP) FIELD_STRUCT_DESC: 24-inch corrugated metal gravity drainage pipe through the levee, 20.3 feet below the crown. Flap gate on the waterside (WS) end. Concrete headwall on each end. Installed by USACE in 1961. [Additional Reference(s): DWR Levee Log, 1992. USACE San Joaquin O&M Manual 6, September 1961, (HLM 2.71)]. FS Date: 11/5/2013

WS view: pipe, flap gate, and concrete headwall on river bank.

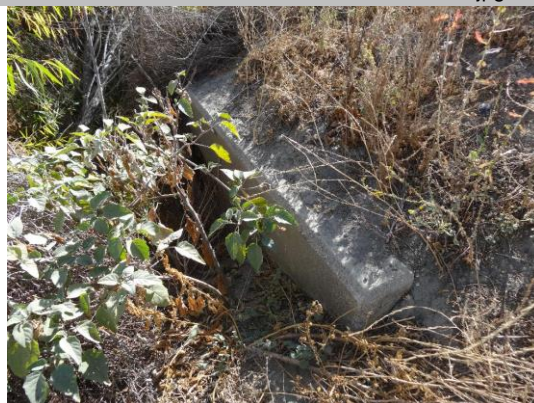
Photo 3 of 3 : UCIP\_FA\_2018\_25023\_45100.jpg

LS view: pipe and concrete headwall off the levee toe.

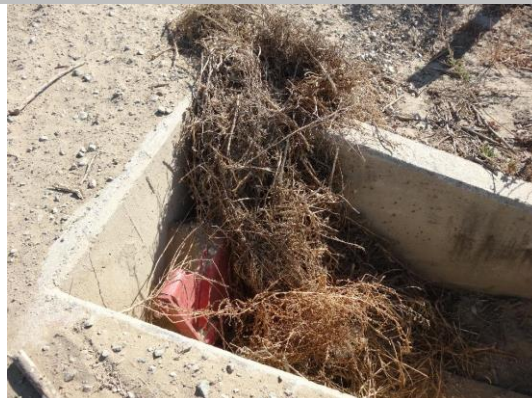
Photo 1 of 3 : UCIP\_FA\_2018\_24443\_43522.jpg

LM Start	2.93	Rating **	M	Issue No.	69	
LM End	2.93	Issue Type +	Ma	Location *		
Category	Supplemental			GPS Latitude/Longitude		
				Start		End
Item	DWR UCIP LMA Responsibility			37.443871 °		37.443871 °
				-121.025775 °		-121.025775 °
DWR ID	22088					
Comment Code						
Inspector Comment						
FS_ID:24443						
DS_ID:22088						
EP_NO: N/A						
Repair Type: Non-Urgent						
Crossing Status: Found						
UCIP Comments: 11/05/2013 - clear and clean debris (P. Amatya - DWR UCIP)						
FIELD_STRUCT_DESC: *ABANDONED* 24-inch corrugated metal gravity drainage pipe through the levee, 9.5 feet below the crown. Flap gate on the waterside (WS) end. Pipe open on the landside (LS) end. Concrete headwall on each end. [Additional Reference(s): DWR Levee Log, 1992. USACE San Joaquin O&M Manual 6, September 1961, (HLM 2.97)].						
FS Date: 11/5/2013

WS view: U typed concrete headwall on levee slope.

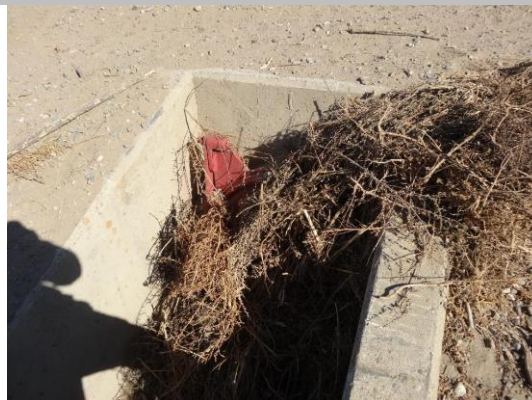
Photo 2 of 3 : UCIP\_FA\_2018\_24443\_43521.jpg

WS view: pipe, flap gate, and concrete headwall with debris blocking the outlet.

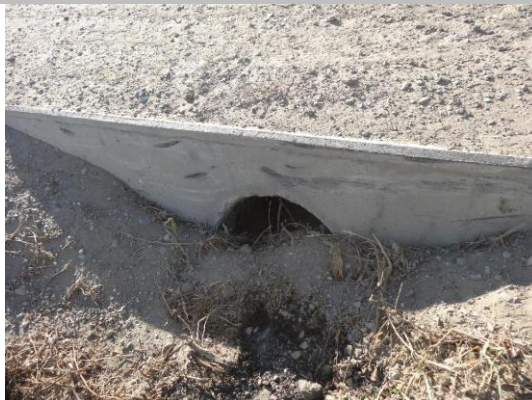
Photo 3 of 3 : UCIP\_FA\_2018\_24443\_43520.jpg

LM Start	2.93	Rating **	M	Issue No.	69 (cont)	
LM End	2.93	Issue Type +	Ma	Location *		
Category	Supplemental			GPS Latitude/Longitude		
				Start		End
Item	DWR UCIP LMA Responsibility			37.443871 °	37.443871 °	
				-121.025775 °	-121.025775 °	
DWR ID	22088					
Comment Code						
Inspector Comment						
FS_ID:24443						
DS_ID:22088						
EP_NO: N/A						
Repair Type: Non-Urgent						
Crossing Status: Found						
UCIP Comments: 11/05/2013 - clear and clean debris (P. Amatya - DWR UCIP)						
FIELD_STRUCT_DESC: *ABANDONED* 24-inch corrugated metal gravity drainage pipe through the levee, 9.5 feet below the crown. Flap gate on the waterside (WS) end. Pipe open on the landside (LS) end. Concrete headwall on each end. [Additional Reference(s): DWR Levee Log, 1992. USACE San Joaquin O&M Manual 6, September 1961, (HLM 2.97)].						
FS Date: 11/5/2013

WS view: pipe, flap concrete headwall with soil debris blocking the inlet.

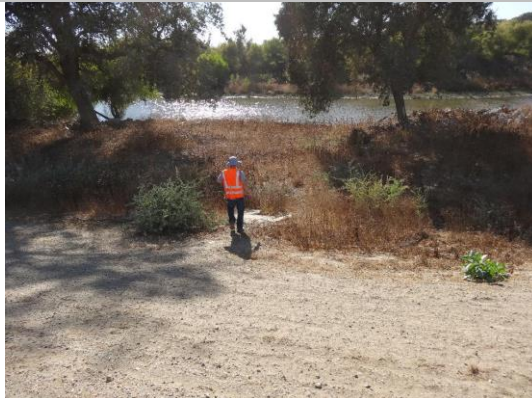
Photo 1 of 3 : UCIP\_FA\_2018\_24469\_43645.jpg

LM Start	3.29	Rating **	M	Issue No.	70	
LM End	3.29	Issue Type +	Ma	Location *		
Category	Supplemental			GPS Latitude/Longitude		
				Start		End
Item	DWR UCIP LMA Responsibility			37.441213 °		37.441213 °
				-121.021130 °		-121.021130 °
DWR ID	22089					
Comment Code						
Inspector Comment						
FS_ID:24469 DS_ID:22089 EP_NO: N/A Repair Type: Non-Urgent Crossing Status: Found UCIP Comments: 11/05/2013 - cleaning required in inlet pipe.- new flap gate (P. Amatya - DWR UCIP) FIELD_STRUCT_DESC: *ABANDONED* 24-inch corrugated metal gravity drainage pipe through the levee, 12.5 feet below the crown. Flap gate on the waterside (WS) end. Concrete headwall on each end. [Additional Reference(s): DWR Levee Log, 1992. USACE San Joaquin O&M Manual 6, September 1961, (HLM 3.33)]. FS Date: 11/5/2013

WS view: U typed concrete headwall on levee toe

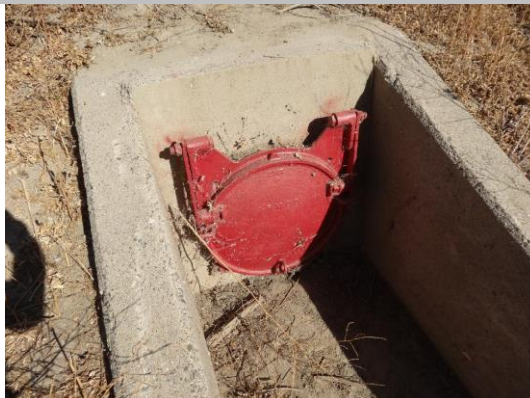
Photo 2 of 3 : UCIP\_FA\_2018\_24469\_43644.jpg

LM Start	3.29	Rating **	M	Issue No.	70 (cont)	
LM End	3.29	Issue Type +	Ma	Location *		
Category	Supplemental			GPS Latitude/Longitude		
				Start	End	
Item	DWR UCIP LMA Responsibility			37.441213 °	37.441213 °	
				-121.021130 °	-121.021130 °	
DWR ID	22089					
Comment Code						
Inspector Comment						
FS_ID:24469 DS_ID:22089 EP_NO: N/A Repair Type: Non-Urgent Crossing Status: Found UCIP Comments: 11/05/2013 - cleaning required in inlet pipe.- new flap gate (P. Amatya - DWR UCIP) FIELD_STRUCT_DESC: *ABANDONED* 24-inch corrugated metal gravity drainage pipe through the levee, 12.5 feet below the crown. Flap gate on the waterside (WS) end. Concrete headwall on each end. [Additional Reference(s): DWR Levee Log, 1992. USACE San Joaquin O&M Manual 6, September 1961, (HLM 3.33)]. FS Date: 11/5/2013

WS view: new flap gate, and U typed concrete headwall.

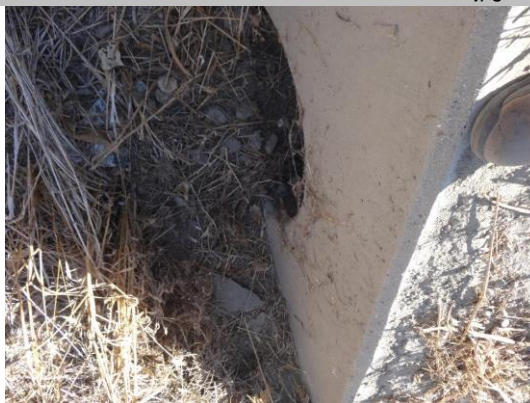
Photo 3 of 3 : UCIP\_FA\_2018\_24469\_43643.jpg

LS view: CM pipe and concrete headwall on levee slope. Debris blocking inlet pipe.

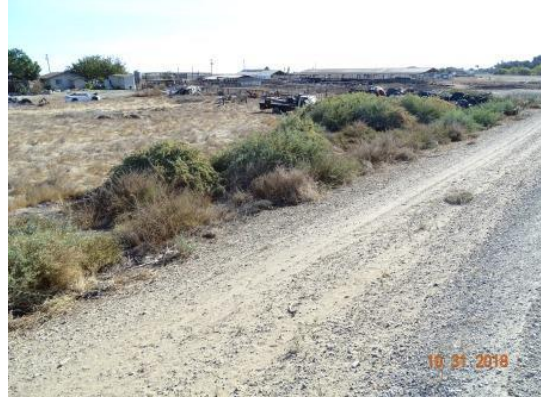
Photo 1 of 1 : FA\_2018\_RD2063\_112\_42\_20181114\_00125.jpg

Heavy brush growing at landside toe. (Fall 2018)

LM Start	3.64	Rating **	M	Issue No.	45
LM End	3.66	Issue Type +	Ma	Location *	LS
Category	Earthen Levee			GPS Latitude/Longitude	
				Start	End
Item	Vegetation			37.436901°	37.436587°
				-121.017868°	-121.017537°
DWR ID	DWR_RD2063_01_f_2018_45				
Comment Code					
V1 : Control annual grass and weeds on the levee slopes and easements.					
Inspector Comment					
Control vegetation growth at the toe of the levee.

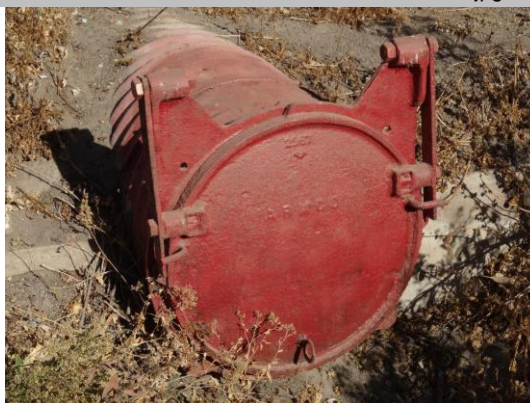
Photo 1 of 3 : UCIP\_FA\_2018\_24485\_43667.jpg

LM Start	3.64	Rating **	M	Issue No.	71
LM End	3.64	Issue Type +	Ma	Location *	
Category	Supplemental			GPS Latitude/Longitude	
				Start	End
Item	DWR UCIP LMA Responsibility			37.436845 °	37.436845 °
				-121.017826 °	-121.017826 °
DWR ID	22093				
Comment Code					
Inspector Comment					
FS_ID:24485 DS_ID:22093 EP_NO: N/A Repair Type: Non-Urgent Crossing Status: Found UCIP Comments: 11/05/2013 - new flap gate on waterside.- cleaning and clearing of inlet box needed. (P. Amatya - DWR UCIP) FIELD_STRUCT_DESC: 24-inch corrugated metal gravity drainage pipe through the levee, 12 feet below the crown. Flap gate and concrete saddle on the waterside (WS) end. Concrete drop inlet box on the landside (LS) end. Installed by USACE in 1961. [Additional Reference(s): DWR Levee Log, 1992. USACE San Joaquin O&M Manual 6, September 1961, (HLM 3.69)]. FS Date: 11/5/2013

WS view: pipe, flap gate, and concrete saddle on levee slope

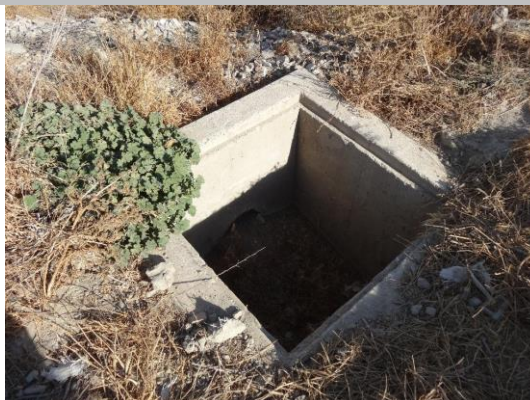
Photo 2 of 3 : UCIP\_FA\_2018\_24485\_43666.jpg

LS view: concrete drop inlet box on levee toe.

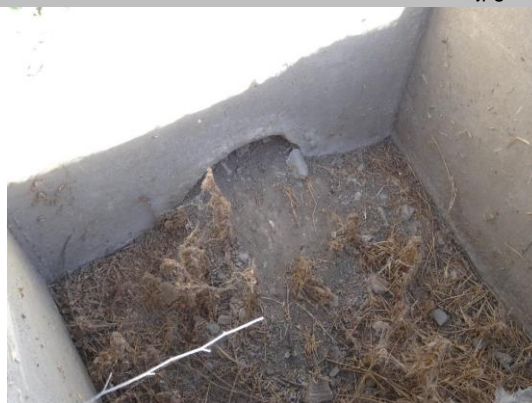
Photo 3 of 3 : UCIP\_FA\_2018\_24485\_43665.jpg

Comment Code						
Inspector Comment						
FS_ID:24485						
DS_ID:22093						
EP_NO: N/A						
Repair Type: Non-Urgent						
Crossing Status: Found						
UCIP Comments: 11/05/2013 - new flap gate on waterside.- cleaning and clearing of inlet box needed. (P. Amatya - DWR UCIP)						
FIELD_STRUCT_DESC: 24-inch corrugated metal gravity drainage pipe through the levee, 12 feet below the crown. Flap gate and concrete saddle on the waterside (WS) end. Concrete drop inlet box on the landside (LS) end. Installed by USACE in 1961. [Additional Reference(s): DWR Levee Log, 1992. USACE San Joaquin O&M Manual 6, September 1961, (HLM 3.69)].						
FS Date: 11/5/2013

LS view: inside view of inlet box on levee toe. Debris blocking inlet pipe.

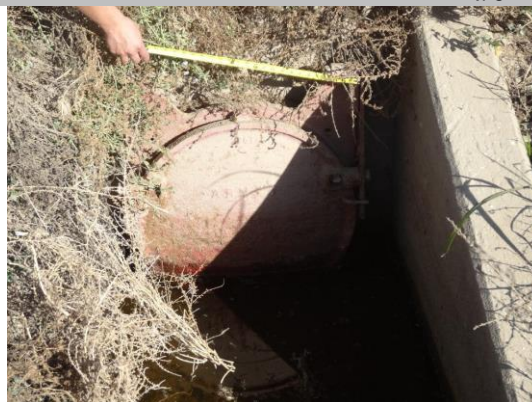
Photo 1 of 3 : UCIP\_FA\_2018\_51821\_43842.jpg

Comment Code					
Inspector Comment					
FS_ID:51821 DS_ID:22096 EP_NO: N/A Repair Type: No Action Needed Crossing Status: Found UCIP Comments: 05/11/2017 Review of photos indicate less than 1/4 of the inlet is silted in. Since the pipe is in good condition, it has been downgraded from Non-Urgent to No Action Needed. (K. Fazel - UCIP)11/05/2013:- new flap gate on waterside.- cleaning of outlet and inlet pipes required. (P. Amatya - DWR) FIELD_STRUCT_DESC: 24-inch corrugated metal gravity drainage pipe through the levee, 12 feet below the crown. Flap gate on the waterside (WS) end. Concrete headwall on each end. Installed by USACE in 1961. [Additional Reference(s): DWR Levee Log, 1992. USACE San Joaquin O&M Manual 6, September 1961, (HLM 4.08)]. FS Date: 11/5/2013

WS view: pipe, flap gate, and concrete headwall on drainage ditch.

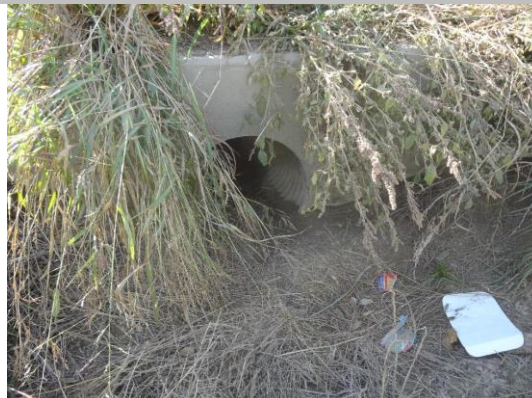
Photo 2 of 3 : UCIP\_FA\_2018\_51821\_43841.jpg

Comment Code						
Inspector Comment						
FS_ID:51821						
DS_ID:22096						
EP_NO: N/A						
Repair Type: No Action Needed						
Crossing Status: Found						
UCIP Comments: 05/11/2017 Review of photos indicate less than 1/4 of the inlet is silted in. Since the pipe is in good condition, it has been downgraded from Non-Urgent to No Action Needed. (K. Fazel - UCIP)11/05/2013:- new flap gate on waterside.- cleaning of outlet and inlet pipes required. (P. Amatya - DWR)						
FIELD_STRUCT_DESC: 24-inch corrugated metal gravity drainage pipe through the levee, 12 feet below the crown. Flap gate on the waterside (WS) end. Concrete headwall on each end. Installed by USACE in 1961. [Additional Reference(s): DWR Levee Log, 1992. USACE San Joaquin O&M Manual 6, September 1961, (HLM 4.08)].						
FS Date: 11/5/2013

LS view: CM pipe and concrete headwall on levee toe.

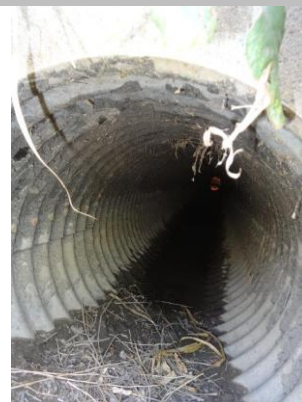
Photo 3 of 3 : UCIP\_FA\_2018\_51821\_43840.jpg

LS view: inside view of the CM pipe on levee toe.

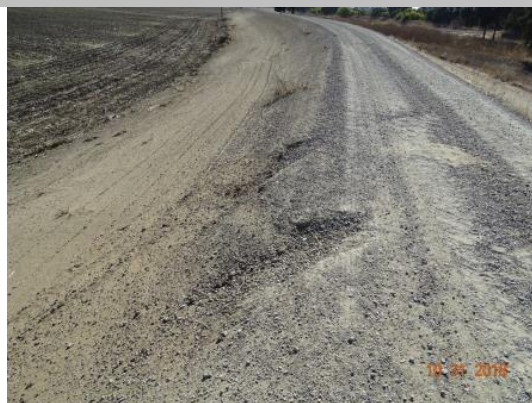
Photo 1 of 1 : FA\_2018\_RD2063\_112\_50\_20181114\_00130.jpg

View of vehicle damage to landside shoulder. (Fall 2018)

LM Start	7.11	Rating **	M	Issue No.	50
LM End	7.11	Issue Type +	Ma	Location *	LS
Category	Earthen Levee			GPS Latitude/Longitude	
				Start	End
Item	Slope Stability			37.406978 °	37.406978 °
				-120.991818 °	-120.991818 °
DWR ID	DWR_RD2063_01_f_2018_50				
Comment Code					
S3 : Repair the levee slope damaged by vehicle traffic and prevent access where possible.					
Inspector Comment					
Repair vehicle damage to landside shoulder.

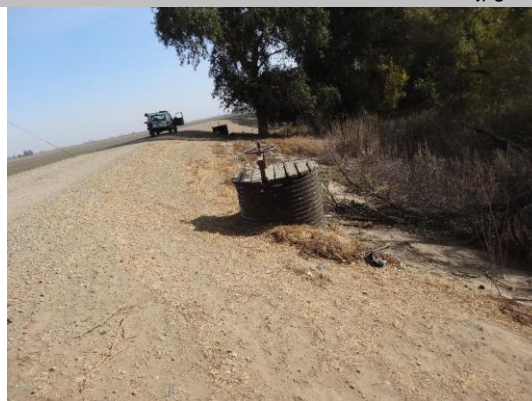
Photo 1 of 3 : UCIP\_FA\_2018\_24632\_43953.jpg

Comment Code					
Inspector Comment					
FS_ID:24632					
DS_ID:22110					
EP_NO: N/A					
Repair Type: No Action Needed					
Crossing Status: Found					
UCIP Comments: 11/06/2013 No pipe visible on landside.Flap gate not found on the waterside end. Concrete "U" headwalls not found on ends of pipe. (P. Amatya - DWR UCIP)					
FIELD_STRUCT_DESC: 36-inch corrugated metal gravity drainage pipe through the levee, 25.5 feet below the crown. Slide gate in a corrugated metal pipe (CMP) riser on the waterside (WS) slope. Flap gate on the WS end. Concrete U-shaped headwall on each end. Installed by USACE in 1961. [Additional Reference(s): DWR Levee Log, 1992. USACE San Joaquin O&M Manual 6, September 1961, (HLM 7.61)].					
FS Date: 11/6/2013

WS view: CMP riser on levee slope. No pipe visible on levee slope.

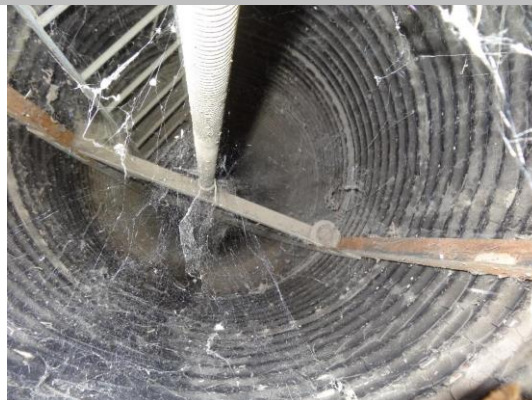
Photo 2 of 3 : UCIP\_FA\_2018\_24632\_43952.jpg

WS view: slide gate in CMP riser on levee slope.

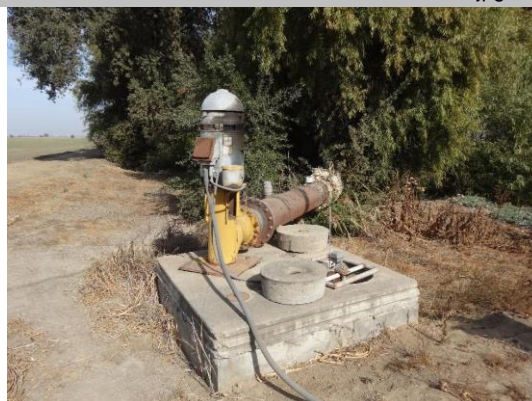
Photo 3 of 3 : UCIP\_FA\_2018\_24632\_43951.jpg

Comment Code						
Inspector Comment						
FS_ID:24632						
DS_ID:22110						
EP_NO: N/A						
Repair Type: No Action Needed						
Crossing Status: Found						
UCIP Comments: 11/06/2013 No pipe visible on landside.Flap gate not found on the waterside end. Concrete "U" headwalls not found on ends of pipe. (P. Amatya - DWR UCIP)						
FIELD_STRUCT_DESC: 36-inch corrugated metal gravity drainage pipe through the levee, 25.5 feet below the crown. Slide gate in a corrugated metal pipe (CMP) riser on the waterside (WS) slope. Flap gate on the WS end. Concrete U-shaped headwall on each end. Installed by USACE in 1961. [Additional Reference(s): DWR Levee Log, 1992. USACE San Joaquin O&M Manual 6, September 1961, (HLM 7.61)].						
FS Date: 11/6/2013

LS view: concrete distribution box on levee toe. Pump on the box discharges water into irrigation ditch.

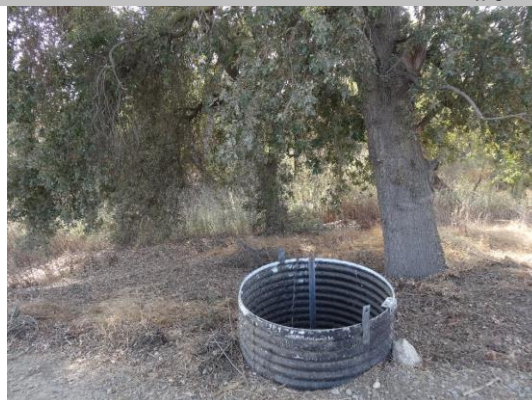
Photo 1 of 3 : UCIP\_FA\_2018\_25031\_45141.jpg

Comment Code					
Inspector Comment					
FS_ID:25031 DS_ID:22111 EP_NO: N/A Repair Type: Non-Urgent Crossing Status: Found UCIP Comments: 11/06/2013 Pump mounted on top of concrete pipe sump not found on the waterside. Concrete standpipe not found on the landward side.Looks abandoned. (P. Amatya - DWR UCIP) FIELD_STRUCT_DESC: *ABANDONED* 12-inch concrete encased steel drainage discharge pipe through the levee, 7 feet below the crown. Slide gate in a corrugated metal pipe (CMP) riser on the waterside (WS) slope. Pipe open on both ends. Installed by USACE in 1961. [Additional Reference(s): DWR Levee Log, 1992. USACE San Joaquin O&M Manual 6, September 1961, (HLM 7.62), 10-inch pipe referenced]. FS Date: 11/6/2013

WS view: CMP riser with slide gate. Missing slide gate handwheel.

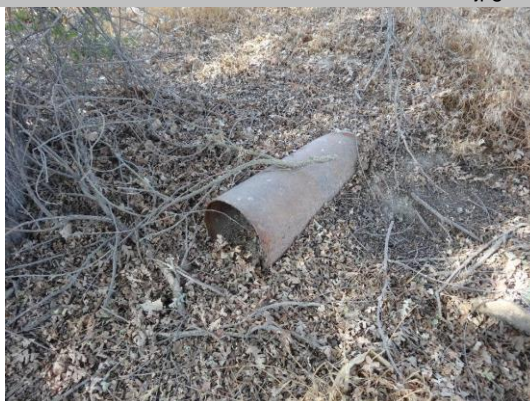
Photo 2 of 3 : UCIP\_FA\_2018\_25031\_45140.jpg

WS view: steel pipe with open-end on waterside slope.

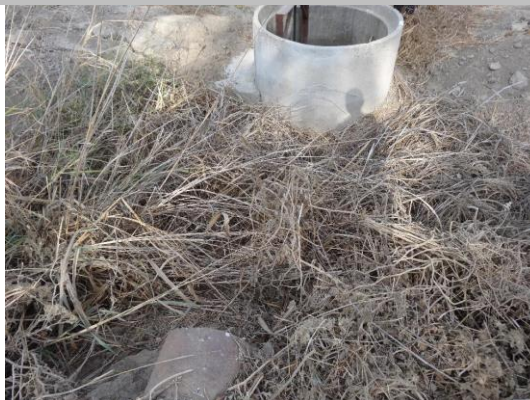
Photo 3 of 3 : UCIP\_FA\_2018\_25031\_45139.jpg

LS view: open-ended steel pipe on levee slope (bottom).

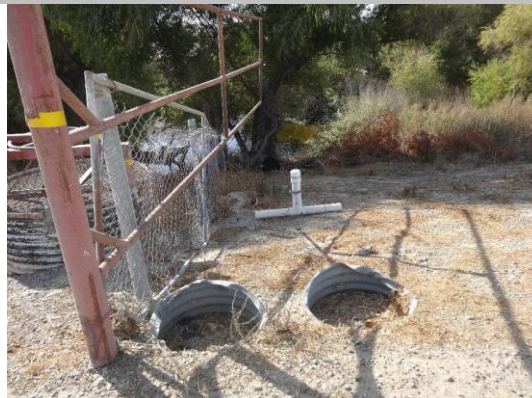
Photo 1 of 3 : UCIP\_FA\_2018\_24651\_44005.jpg

WS view: two siphon breakers in CMP risers on levee slope.

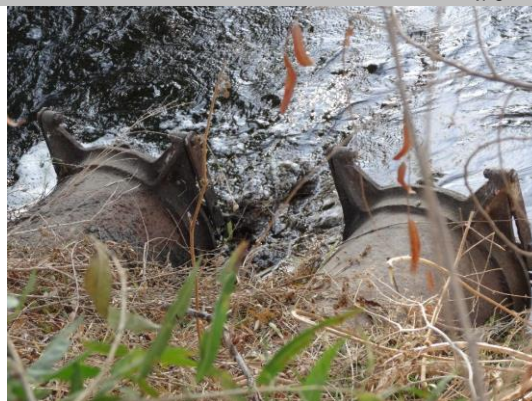
Photo 2 of 3 : UCIP\_FA\_2018\_24651\_44004.jpg

WS view: two flap gates on outfall pipe ends.

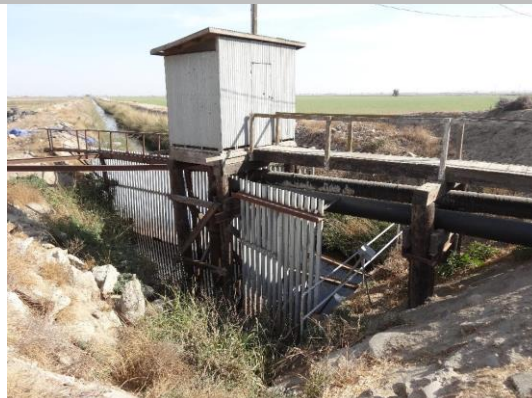
Photo 3 of 3 : UCIP\_FA\_2018\_24651\_44003.jpg

LS view: pipes under walkway to pump house.

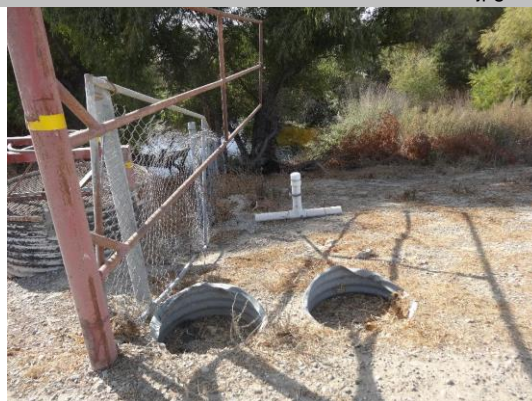
Photo 1 of 3 : UCIP\_FA\_2018\_24652\_44008.jpg

WS view: two siphon breakers in CMP risers on levee slope.

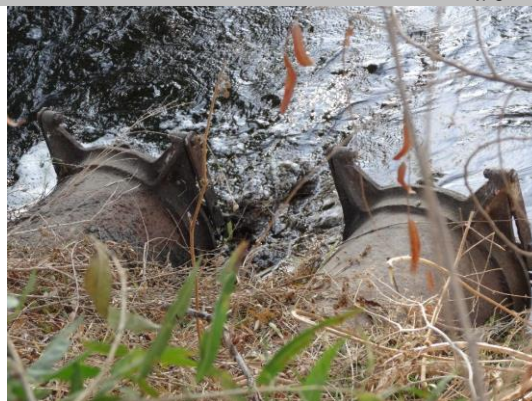
Photo 2 of 3 : UCIP\_FA\_2018\_24652\_44007.jpg

WS view: two flap gates on outfall pipe ends.

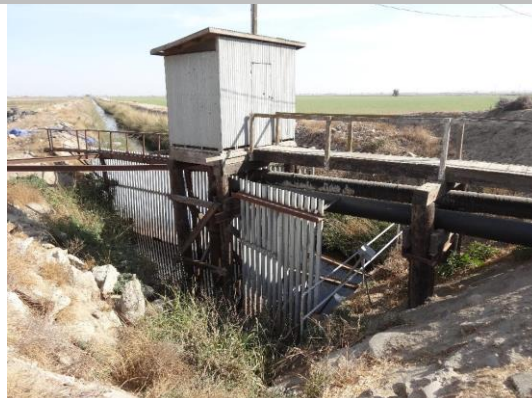
Photo 3 of 3 : UCIP\_FA\_2018\_24652\_44006.jpg

LS view: pipes under walkway to pump house.

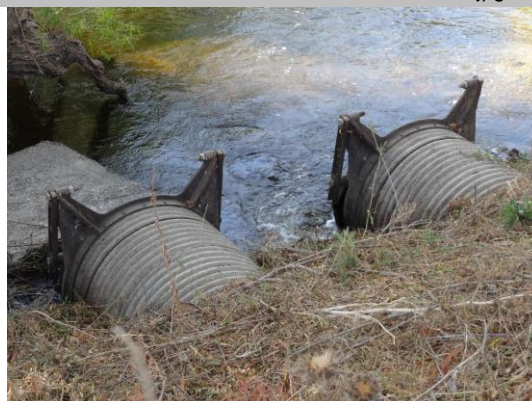
Photo 1 of 3 : UCIP\_FA\_2018\_24650\_44002.jpg

WS view: two flap gates on outfall pipe ends.

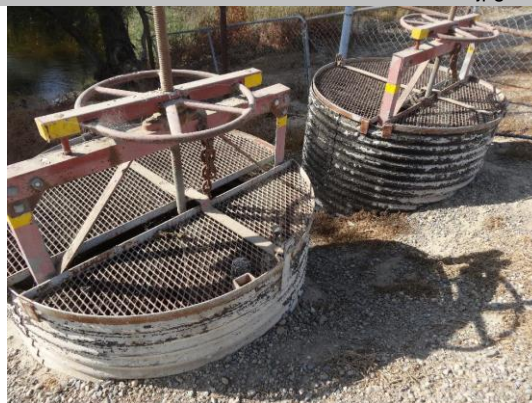
Photo 2 of 3 : UCIP\_FA\_2018\_24650\_44001.jpg

WS view: two slide gates in CMP risers on levee slope.

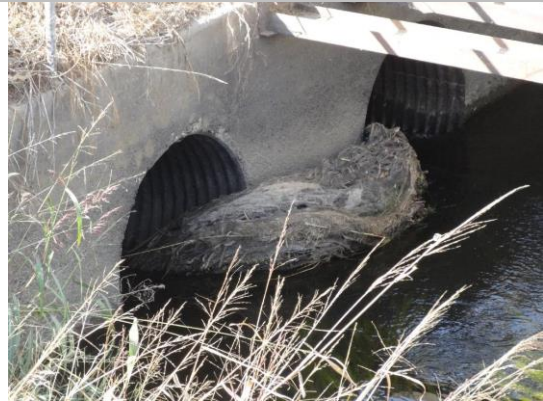
Photo 3 of 3 : UCIP\_FA\_2018\_24650\_44000.jpg

LS view: drainage pipes under walkway in drainage ditch.

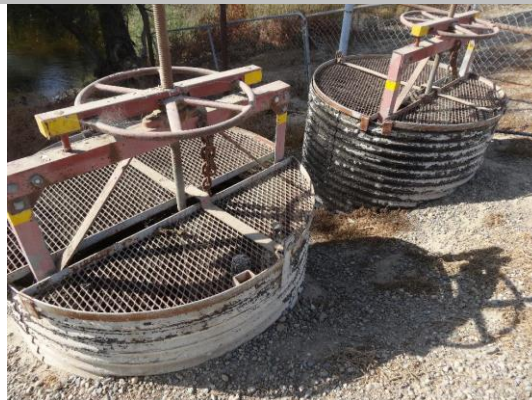
Photo 1 of 3 : UCIP\_FA\_2018\_24636\_43965.jpg

WS view: two slide gates in CMP risers on levee slope

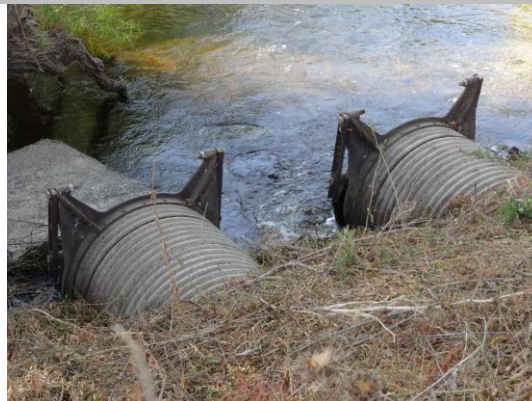
Photo 2 of 3 : UCIP\_FA\_2018\_24636\_43964.jpg

WS view: two flap gates on outfall pipe ends.

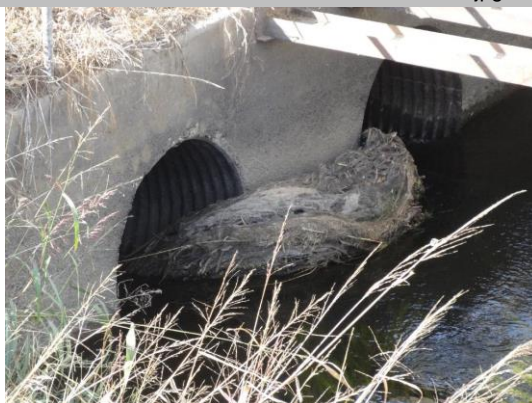
Photo 3 of 3 : UCIP\_FA\_2018\_24636\_43963.jpg

LS view: drainage pipes under walkway in drainage ditch.

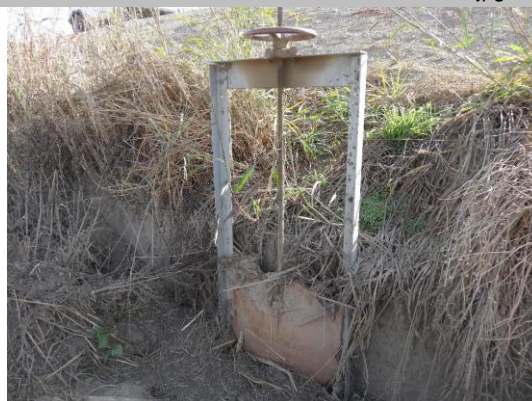
Photo 1 of 2 : UCIP\_FA\_2018\_24638\_43967.jpg

WS view: concrete headwall on levee end. Slide gate on pipe end.

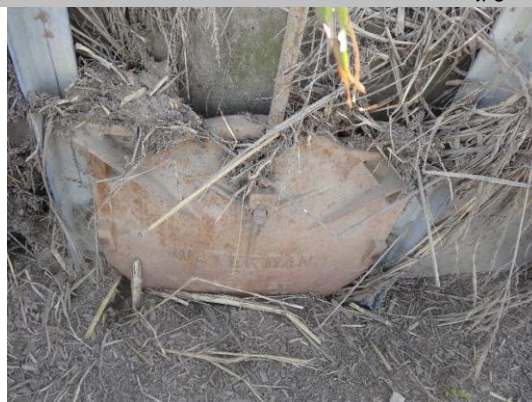
Photo 2 of 2 : UCIP\_FA\_2018\_24638\_43966.jpg

WS view: close view of slide gate on pipe end.

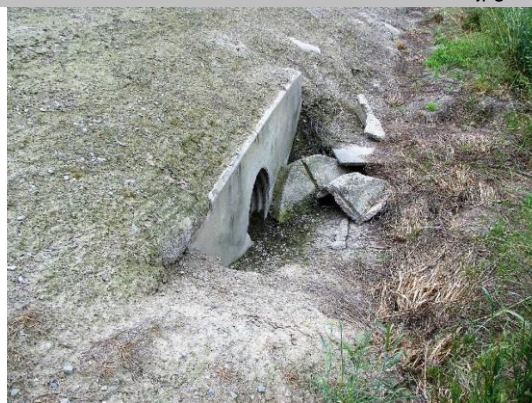
Photo 1 of 3 : UCIP\_FA\_2018\_51825\_77044.jpg

LS inlet as of 4/11/2017 levee inspection. Photo courtesy of DWR inspector Richard Willoughby.

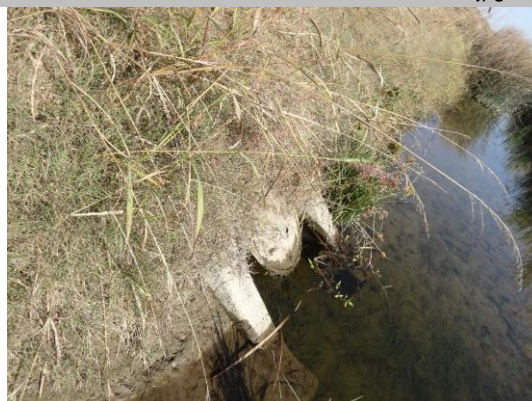
Photo 2 of 3 : UCIP\_FA\_2018\_51825\_43983.jpg

WS view: U type headwall and flap gate visible on the bank of the water channel.

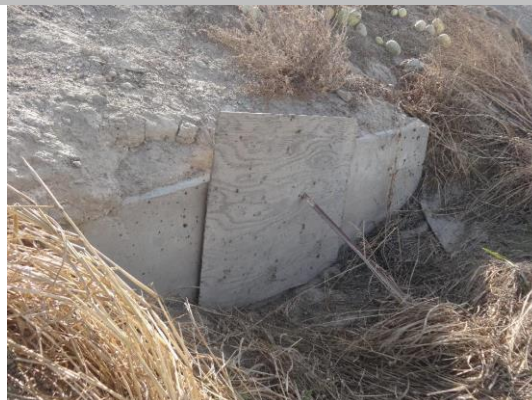
Photo 3 of 3 : UCIP\_FA\_2018\_51825\_43982.jpg

LS view: concrete headwall on levee end. Pipe opening blocked by plywood.

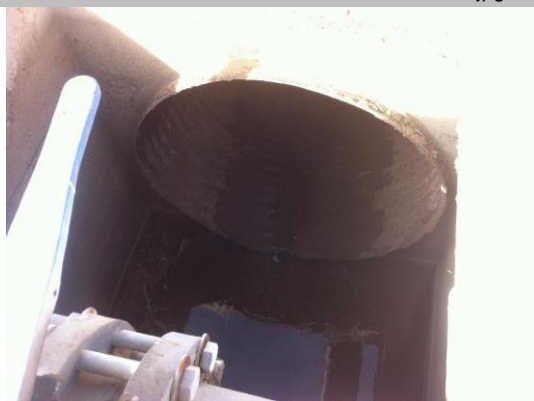
Photo 1 of 3 : UCIP\_FA\_2018\_24644\_43986.jpg

WS view: CM pipe on outlet concrete box.

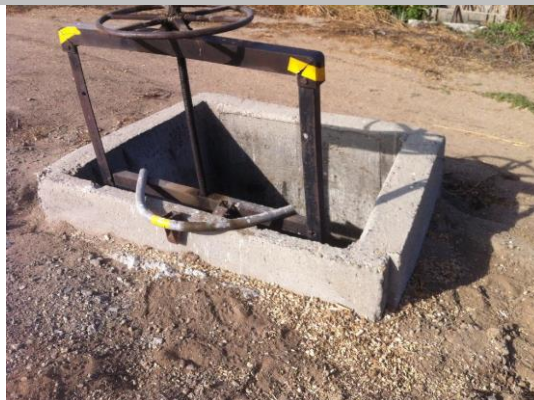
Photo 2 of 3 : UCIP\_FA\_2018\_24644\_43985.jpg

LS view: CM pipe with slide gate on inlet concrete box.

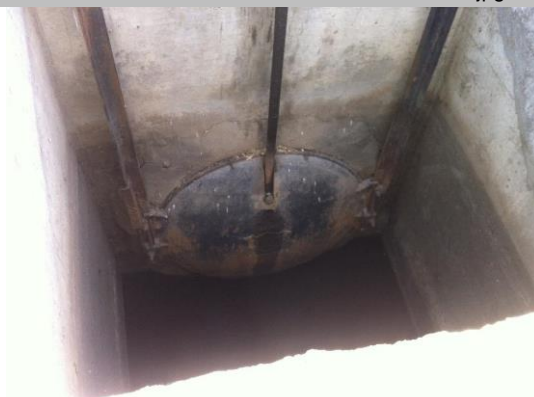
Photo 3 of 3 : UCIP\_FA\_2018\_24644\_43984.jpg

LS view: inside view of slide gate in concrete box.

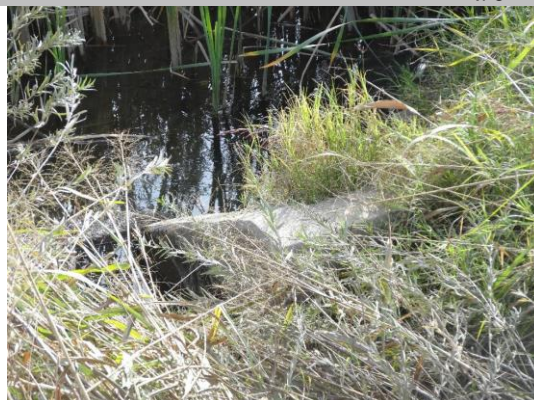
Photo 1 of 2 : UCIP\_FA\_2018\_24645\_43988.jpg

WS view: concrete U type headwall on channel bank. Not accessible.

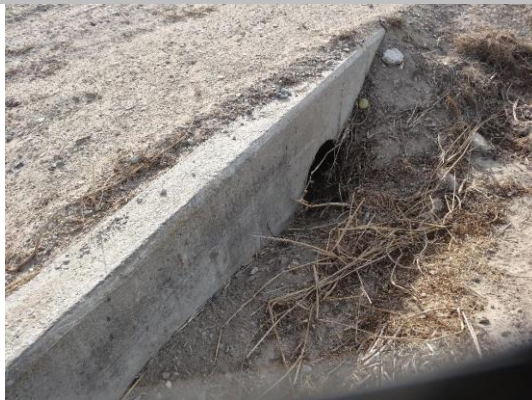
Photo 2 of 2 : UCIP\_FA\_2018\_24645\_43987.jpg

LS view: concrete headwall and partially blocked inlet opening.

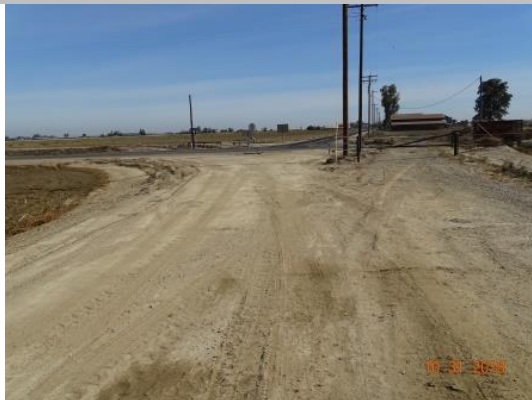
Photo 1 of 1 : FA\_2018\_RD2063\_112\_54\_20181114\_00133.jpg

View of unpermitted ramp coming off of street. (Fall 2018)
